REPORT ON ACCESSIBILITY AND DISABILITY INCLUSION ON THE PUBLIC TRANSPORT SYSTEM IN PHNOM PENH

Previous Journey Access Tool (JAT) studies and national technical standards on physical accessibility

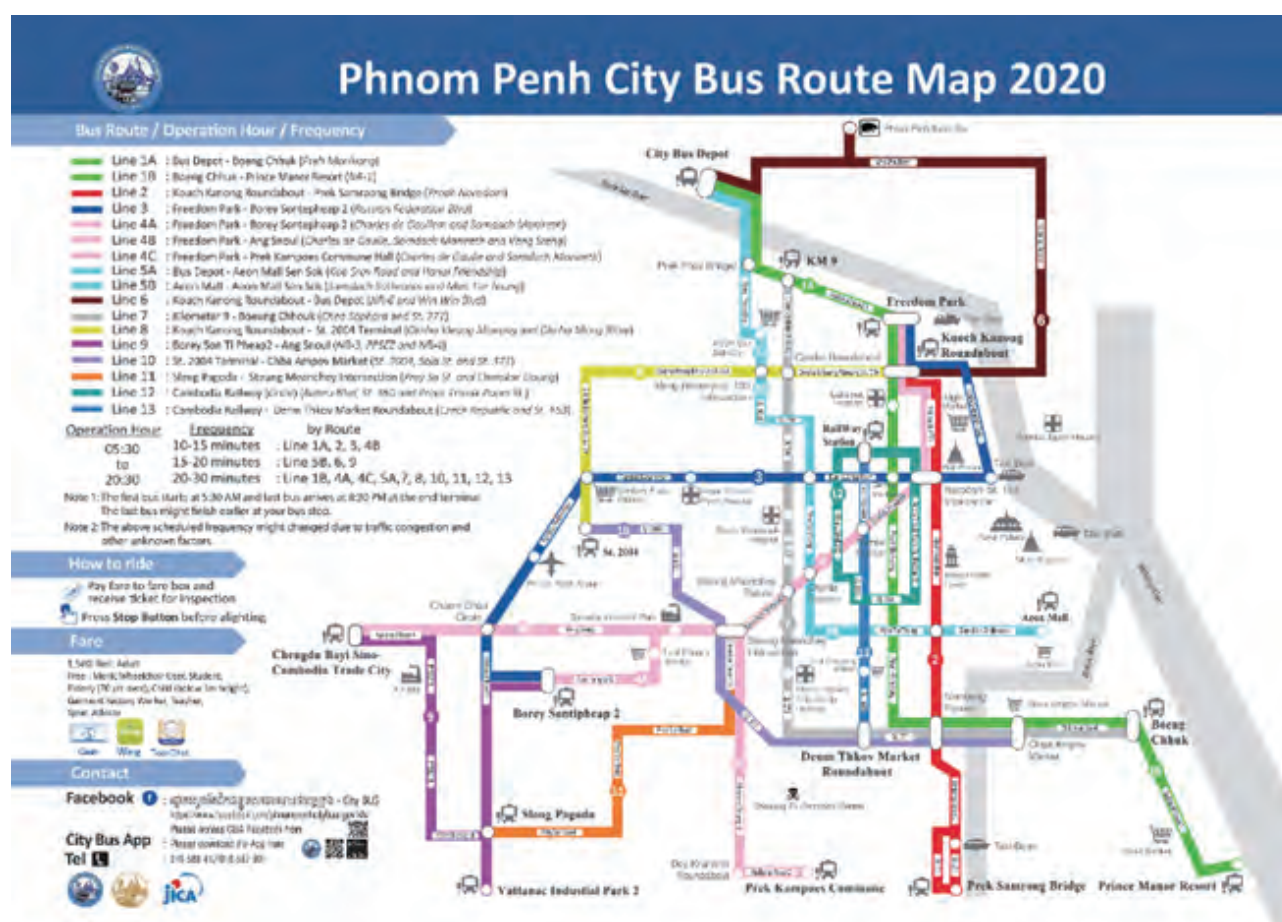
Figure 1: Phnom Penh City Bus Route Map, 2020 (Phnom Penh Capital, 2020)

With the new fleet, the City Bus Authority (CBA)⁸ expanded its service network from three lines in 2016 to 13 in 2018, covering most of Phnom Penh. Compared to the bus routes in 2020, these four corridors are covered by 13 bus routes as shown in Figure 1 - a serving the city's 14 Khans (Boeung Keng Kang, Chamkar Mon, Chbar Ampov, Chraoy Chongvar, Dangkao, Doun Penh, Kamboul, Mean Chey, Praek Pnov, Prampir Meakkakra, Po Senchey, Russey Keo, Saen Sok, and Tuol Kouk). The public bus is currently managed and operated by the CBA, which was established in 2015. These expanded bus routes also helped to increase ridership – from 7,000 passengers per day in 2017 to around 30,000 in 2019. However, the city bus operations have been significantly impacted by the COVID-19 outbreak since early 2020. The public bus services were temporarily suspended due to the pandemic. On November 2, 2021, the bus services resumed but with limited availability, operating only four bus routes⁹ (Line 1A: from Bus depot at Prek Pnov-Boeng Chhuk (Preh Monivong), Line 2: from Kouch Kanong roundabout-Prek Samrong Bridge (Preh Norodom), Line 3: from Freedom Park-Borey Santepheap 2 (Russian Federation Blvd.), Line 4A: Freedom Park- Borey Santepheap 2 (Charles De Gaulle and Samdach Monireth), and Line 4B: From Freedom Park-Ang Snoul (Charles De Gaulle, Samdach Monireth, and Veng Sreng Blvd.). Thus, HI conducted JAT with these four bus routes only.

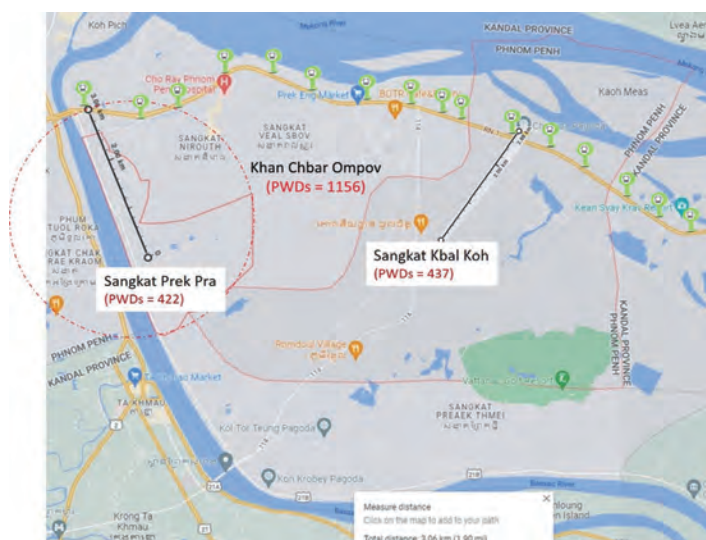
Figure 3: Two Sangkats have the highest number of people with disabilities in Khan Chhbar Ompov

As described in Figure 2 below, Khan Chbar Ampov in Phnom Penh has the highest disability rate. In addition, a high number of persons with disabilities live in Sangkat Kbal Koh (461), and Sangkat Prek Pra (447) located in Khan Chbar Ampov. Only one bus route (Line 1A+1B) with 25 bus stops is available for the Khan Chbar Ampov and the nearest bus stop is around 2-3 km from these Sangkats.

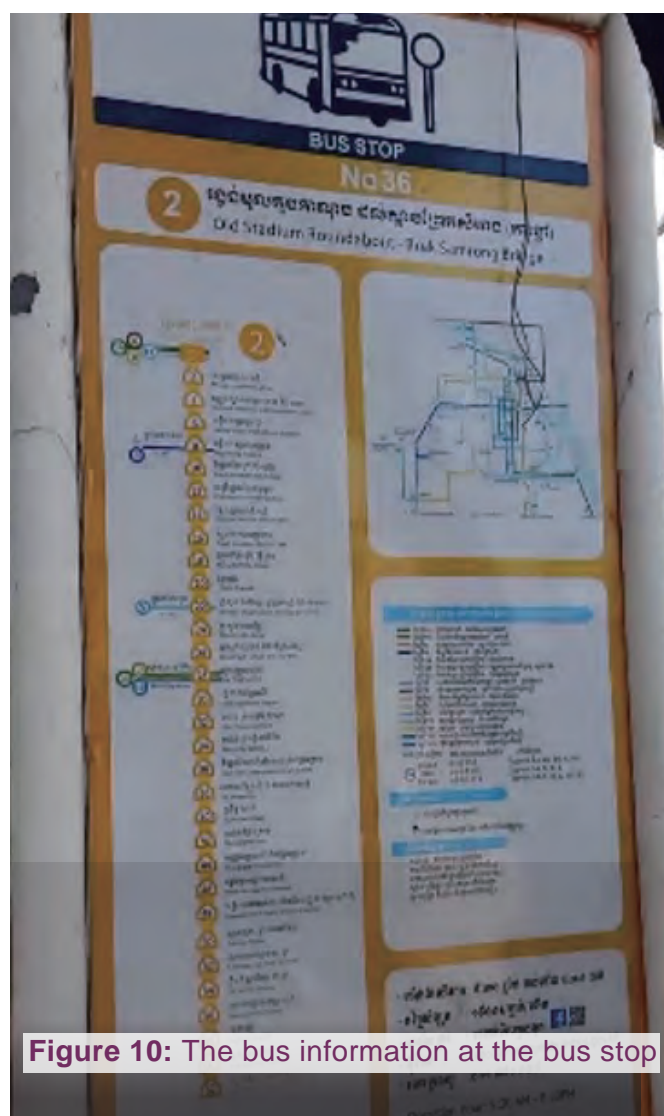
Figure 10: The bus information at the bus stop

Persons with sensory disabilities found it difficult to identify the bus stop or could not recognize the bus stop without assistance since they could not have access to the information board or there was no accessible device installed for them. ***“It is difficult to identify a bus stop. When***

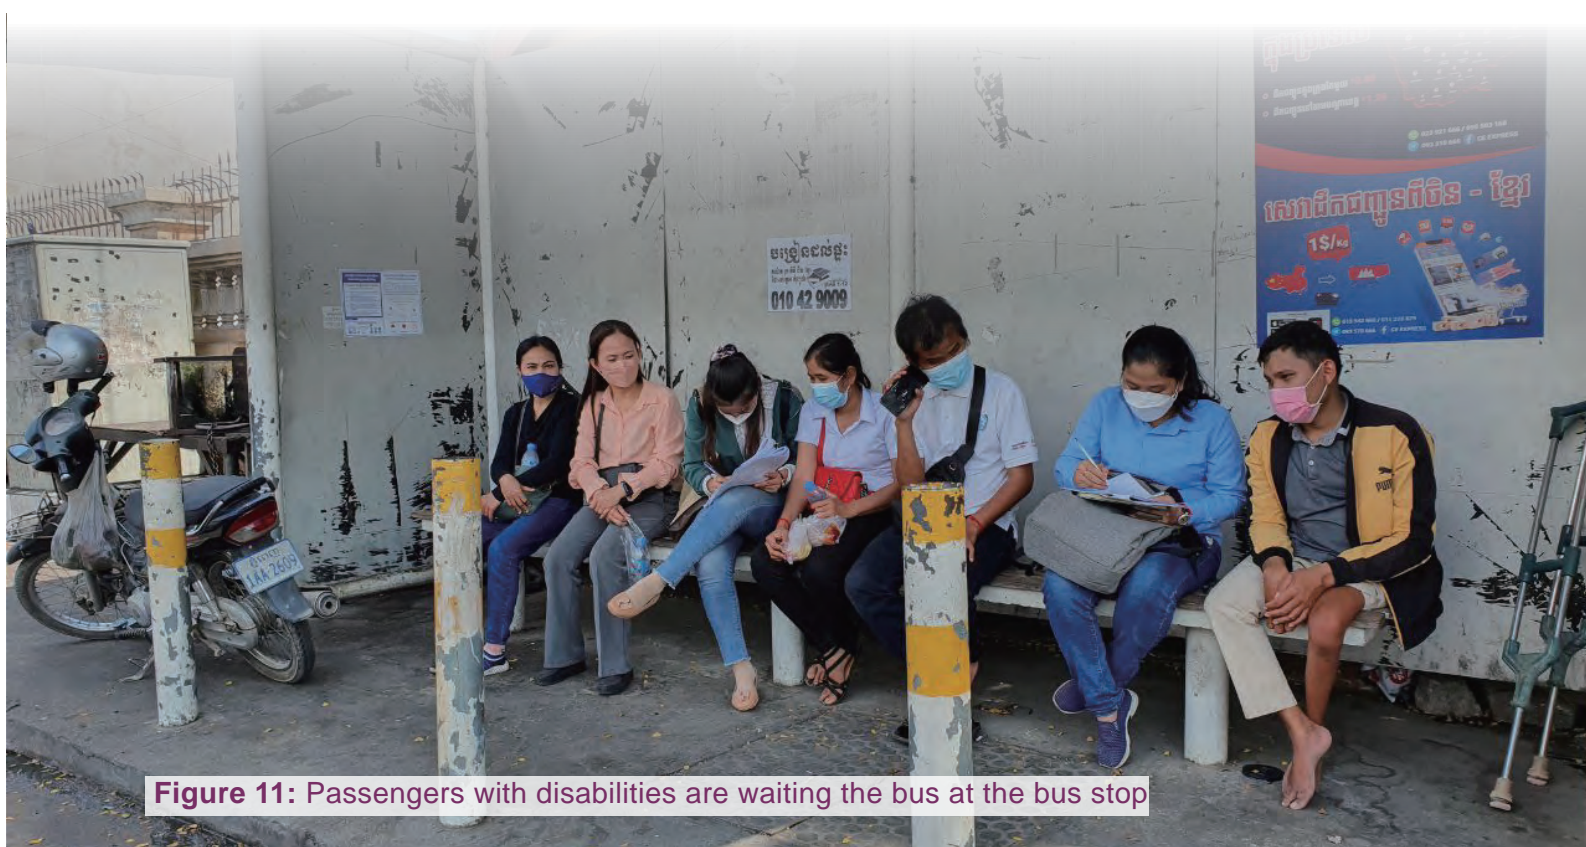
Figure 11: Passengers with disabilities are waiting the bus at the bus stop

Even though some bus stops have shelters, it is observed that the shelters are not big enough and the roofs are damaged. ***“It is wet if it is raining, and it is hot if it is daytime”*** said one participant. Another barrier is that motorcycles, rickshaws, or food carts always park at the bus stop and block the entrance, so persons with disabilities find it difficult to get through to the waiting areas. In some cases, there is a bad smell at the bus stop because of rubbish; no trash bin is available at the bus stop.

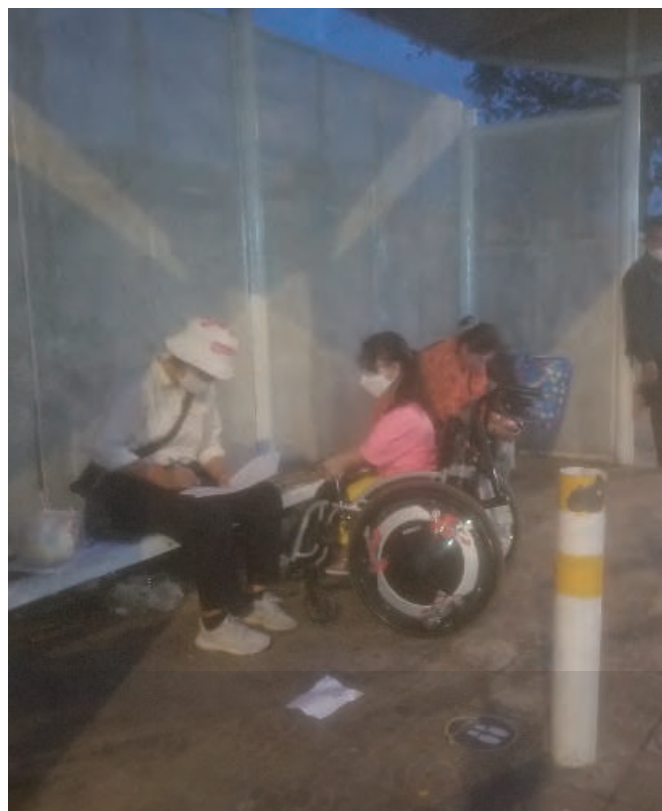
Figure 12: Women with disabilities are waiting for the bus at nighttime

More than half felt frightened and scared at the bus stops especially at night because of no lights, no security camera, and the long waiting time. “...***It is quiet at night because there are few people at the bus stop and a long time is needed for waiting for the bus.I felt worried and scared about addicts, thieves, or crooks while I waited for the bus***”, said one participant. No lights are installed at some bus stops and there are no security cameras at bus stops.

16 females with disabilities said that they felt unsafe and scared of being abused or robbed especially at nighttime. “***I felt frightened because of nighttime***” said one participant. Three females with disabilities thought that they were safe at bus stops; one had experience using the bus before and another believed that it is safe because there are many people around at the bus stop.

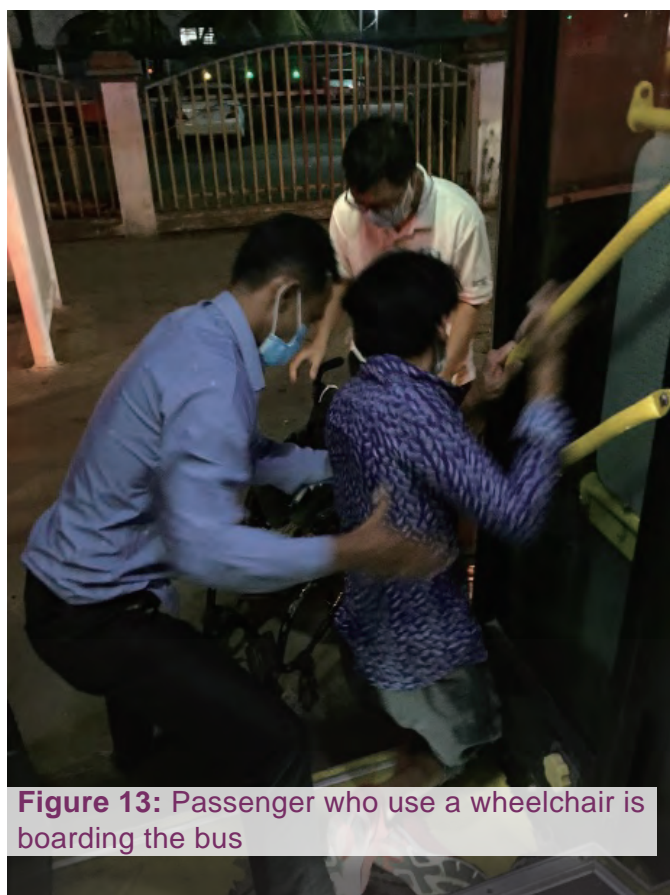
Figure 13: Passenger who use a wheelchair is boarding the bus

The assessed buses all have steps. Some participants had no problem with this, but others found the steps too high for them and with no handrail to provide assistance. Participants also complained that no one helped them to get on the bus. There is no accessible ramp from the bus stop to facilitate their entry to the bus. Some buses have bus assistants but most have only drivers, so it is hard for people with disabilities to request assistance when boarding. Most participants needed assistance to get on the buses, and one noted that they “***felt scared because there is no one there to help***”.

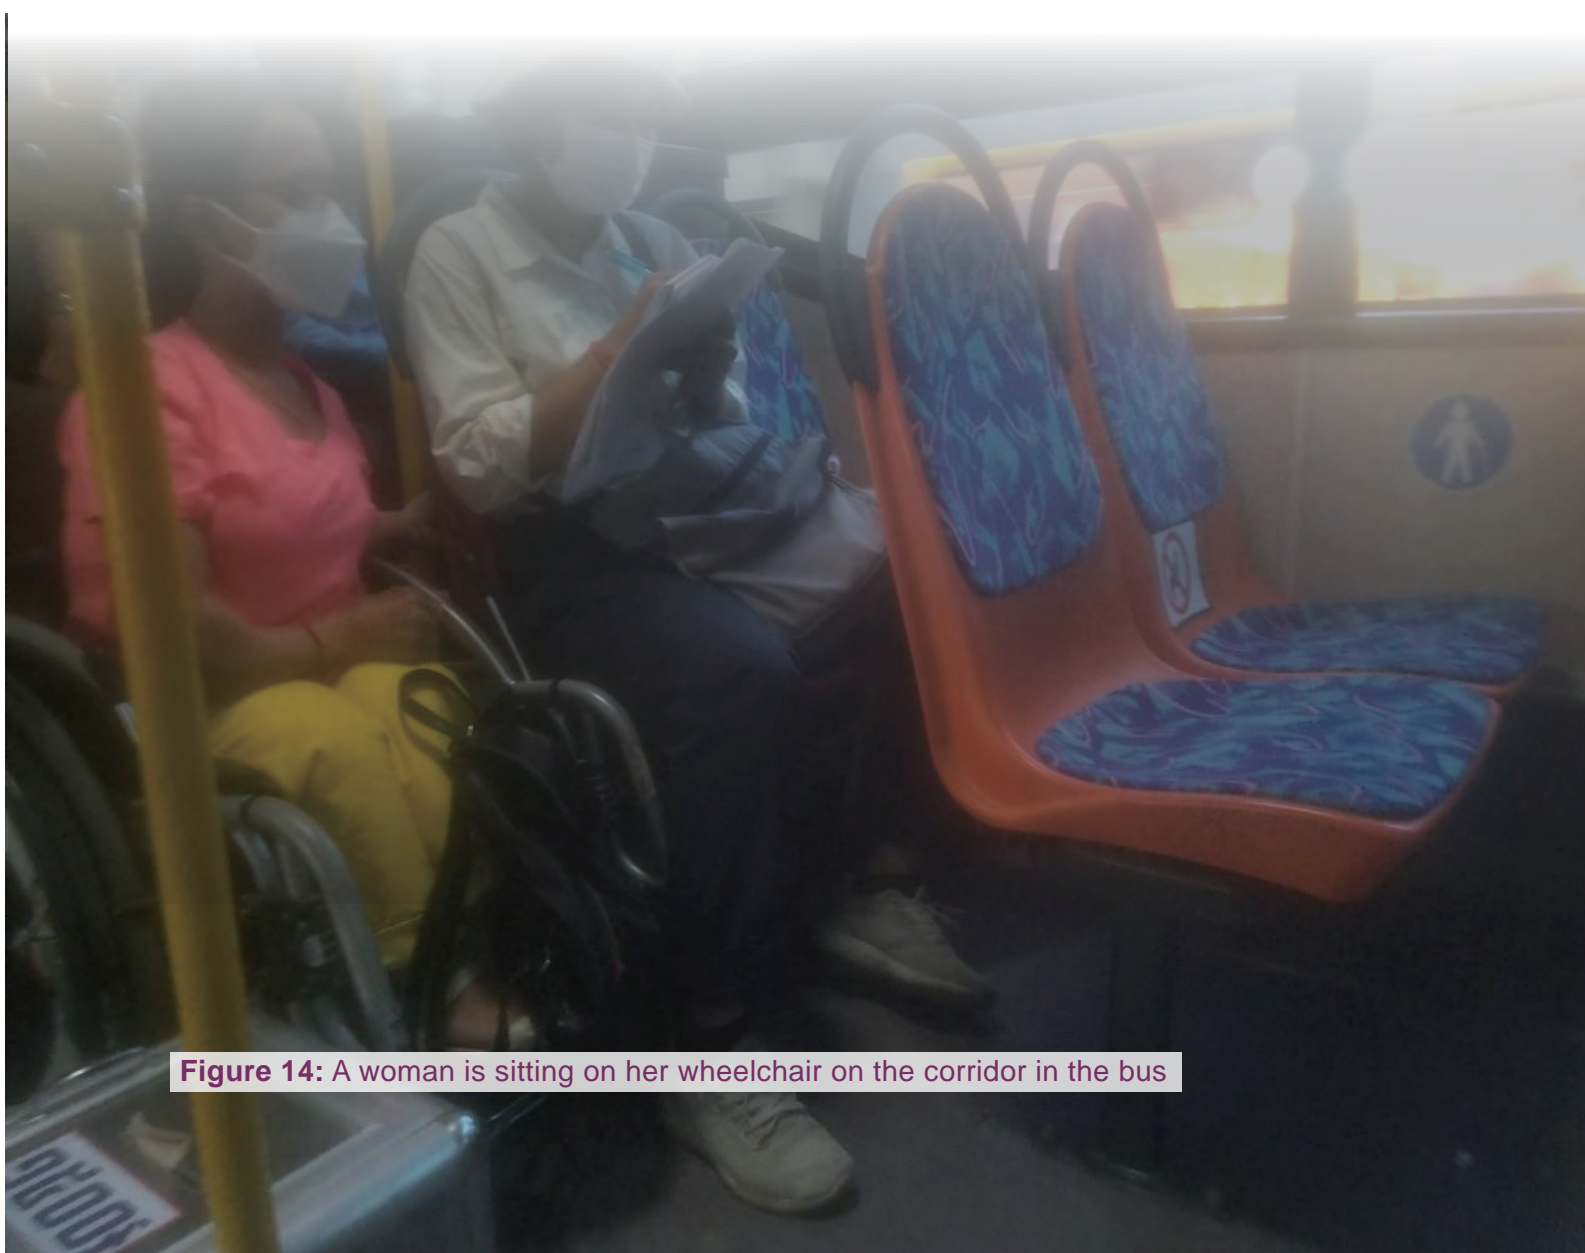
Figure 14: A woman is sitting on her wheelchair on the corridor in the bus

Most buses do not have space to store wheelchairs. Persons with disabilities have to put their wheelchairs next to their seats where there is only the narrow space of the corridor, which causes inconveniences to other passengers. ***“I am afraid of other people complaining”*** said one participant. Another participant said the bus is not designed for persons with disabilities. 22 participants said there was no service information provided in alternative forms such as Braille or audio on the bus. One person with disabilities felt stressed while they were on the bus but their wheelchair was not yet on the bus.

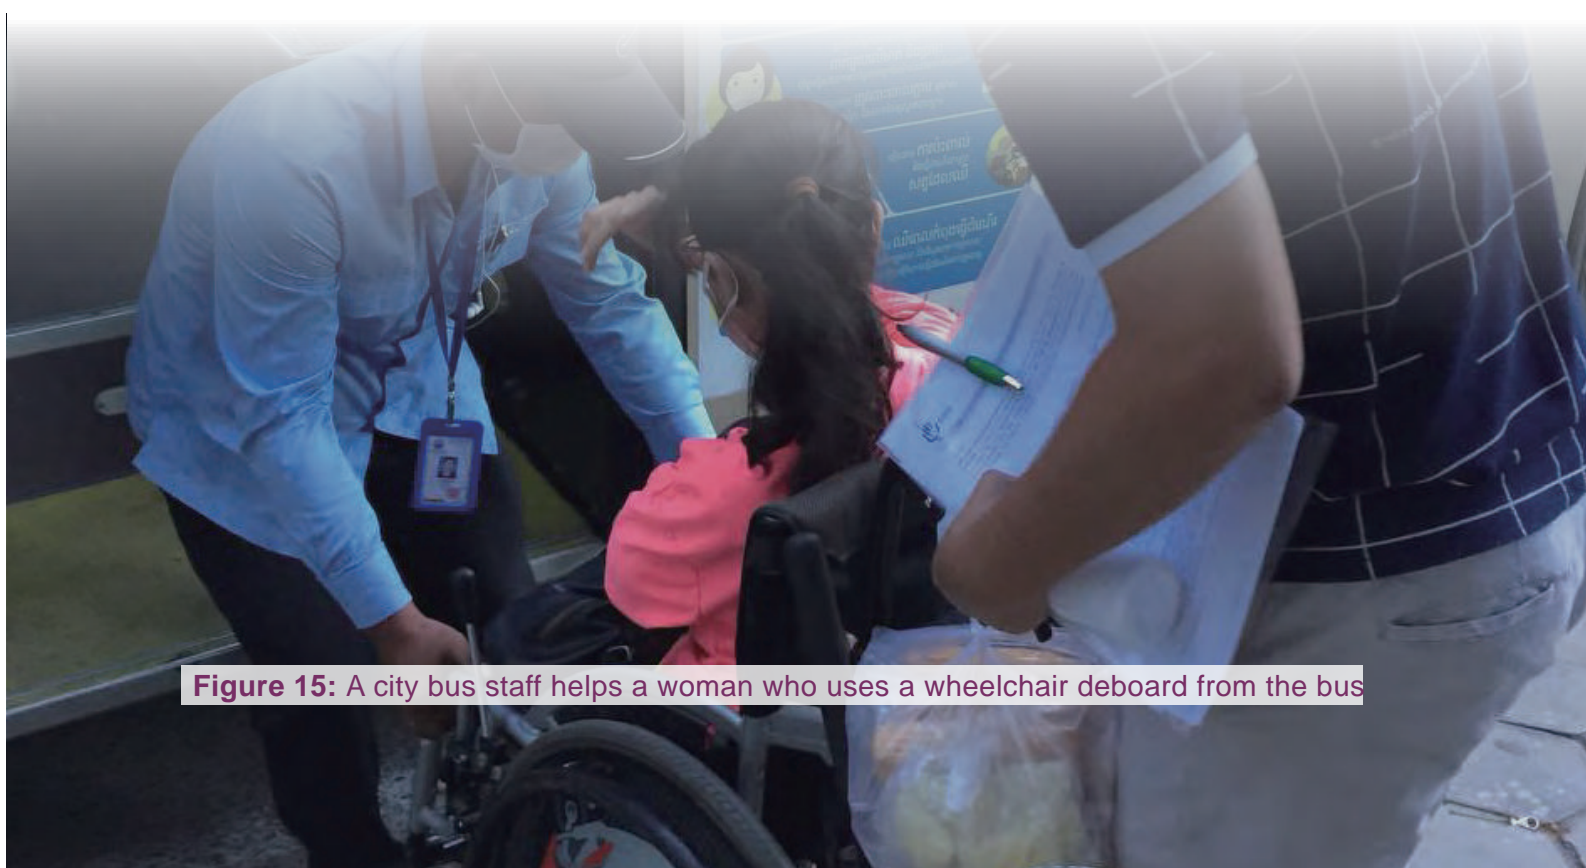
Figure 15: A city bus staff helps a woman who uses a wheelchair deboard from the bus

Few buses have ways for participants to inform drivers where they want to get off. There is no landing pad when de-boarding. There are bus stops, but the barriers for persons with disabilities were found similar to the bus stops before boarding.

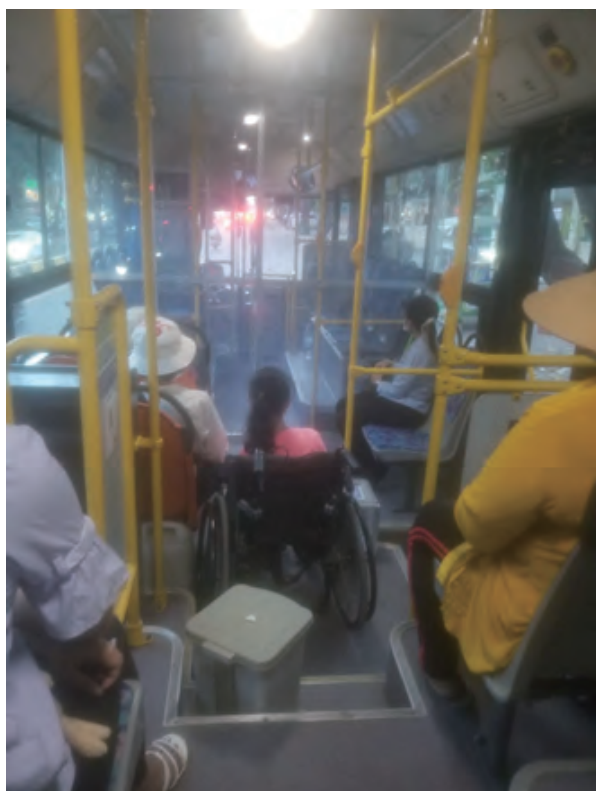
Figure 19: A woman sitting on her wheelchair in the bus donated by China

- ☉ Perspectives of the bus drivers noted that the Chinese buses were better suited to people with disabilities because of lower floors and greater space.
